Inspection Number:
68027
Inspection Address:
Xxxx Xxxxx

TYPE OF BUILDING: Commercial;
Office Center

INSPECTION DATE: October 17, 2011

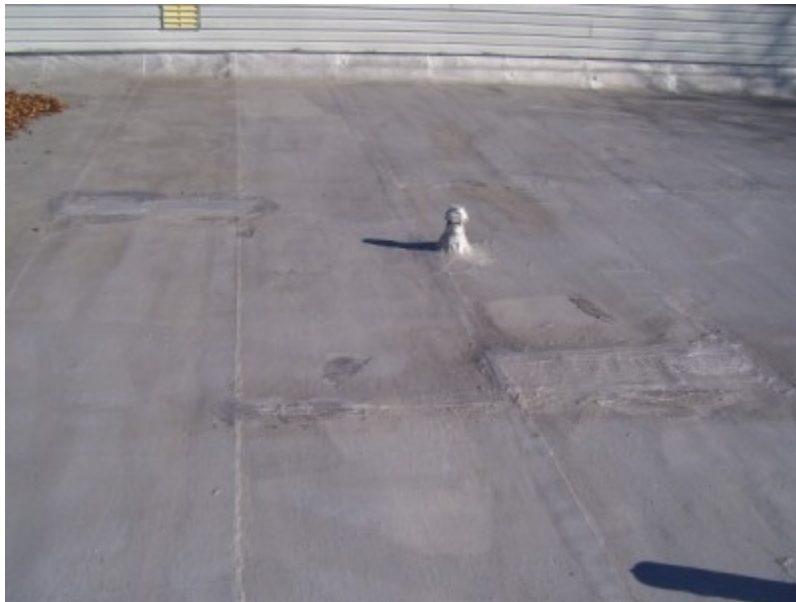
Over the low slope roof, a modified bitumen roofing system is installed. There has been numerous patches and repairs throughout this roof system. Many of the repairs appear to be simply roofing cement applied to joints and seams that may have been suspected of leaking. Using roofing cement for repairs has a very limited life. The asphalt-based patching compound tends to dry out and crack fairly quickly, thus additional repairs will likely be needed. I recommend any future repairs be performed by a roofing contractor experienced with modified bitumen roofing membranes.

12. Monitor, maintain and repair the low-slope roof system as needed.

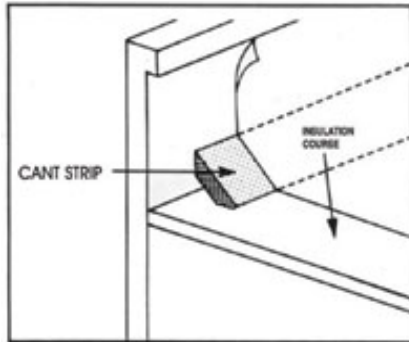
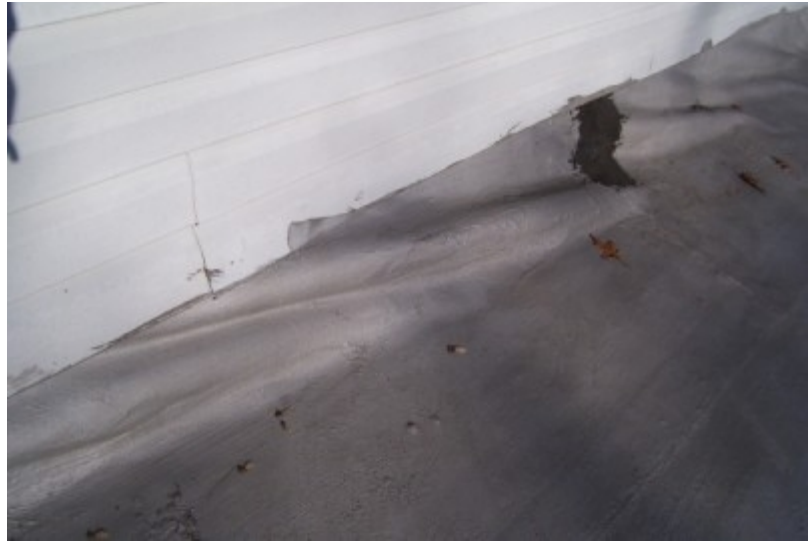
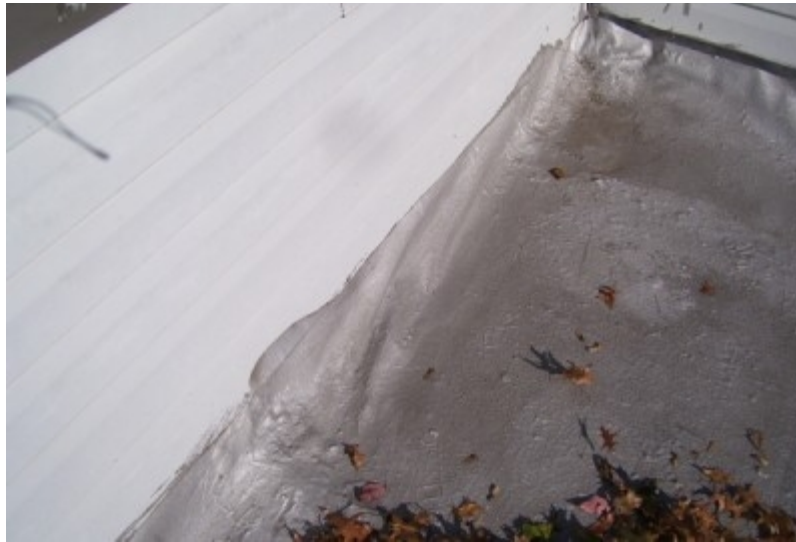
Where the low slope roof transitions to the wall, there is fairly severe wrinkling of the material. This likely would not have occurred if the proper sloped backing was installed at these transitions. A "cant strip" should have been installed. Where the membrane has wrinkled, it will likely crack or tear and should be monitored.

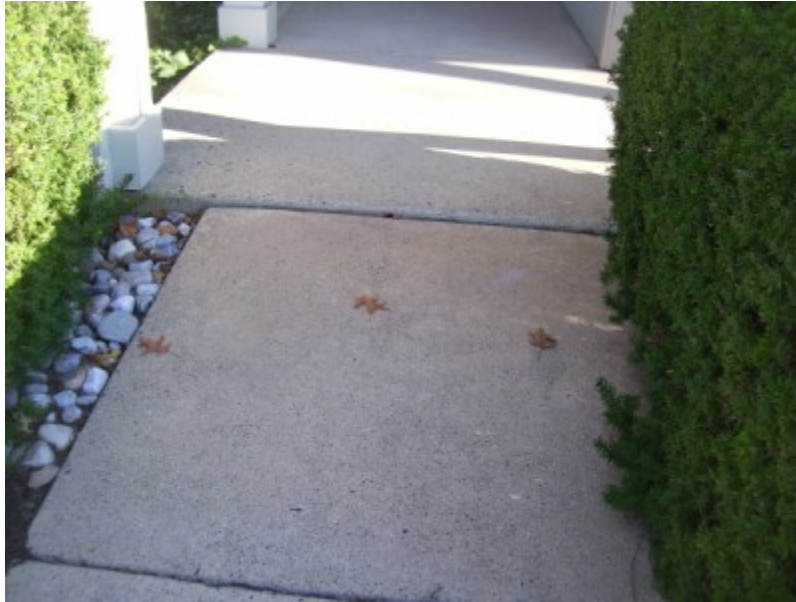
At the right end of the building there is a concrete ramp up to the covered entry walkway however, there is also a raised edge that should be corrected.

1. Correct any possible tripping hazards of the concrete walks.
2. Repair the low spot on the asphalt parking area where there is standing water.
3. Ventilate the front cross gable roof.

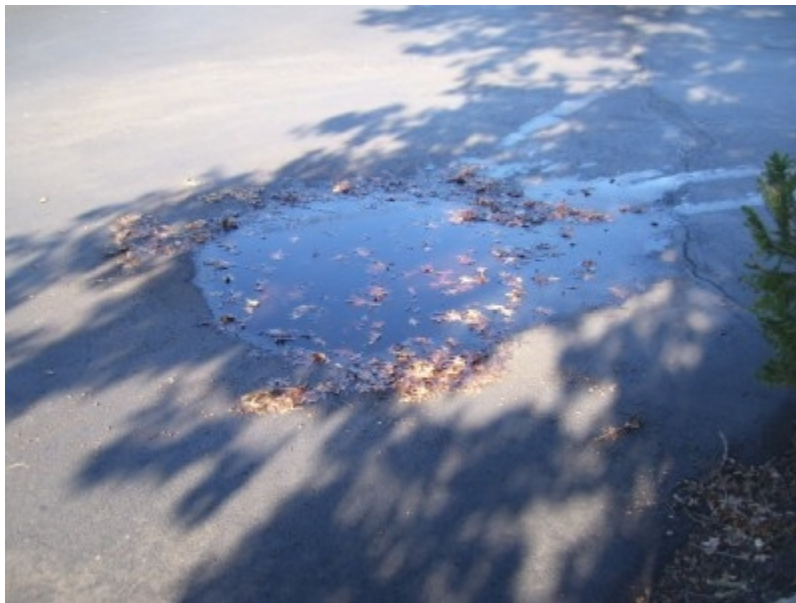
An asphalt parking area is provided. A majority of the asphalt surfaces are satisfactory with some typical cracks evident. There is one area where there is a fairly significant depression where water is ponding. Have this repaired for safety. There is no dedicated handicap parking spaces marked.

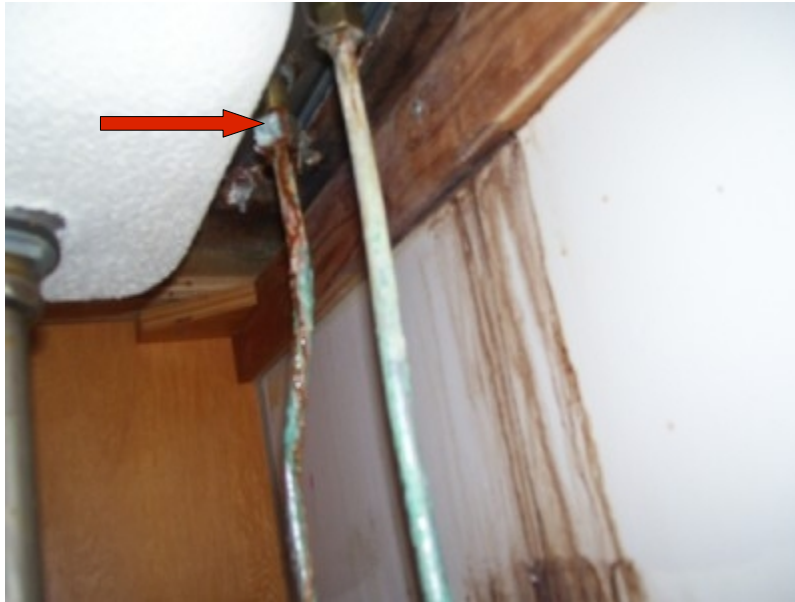
In the accountant office, there is a leak below the hot water faucet into the cabinet below the kitchen sink.

Have a plumbing contractor make repairs.

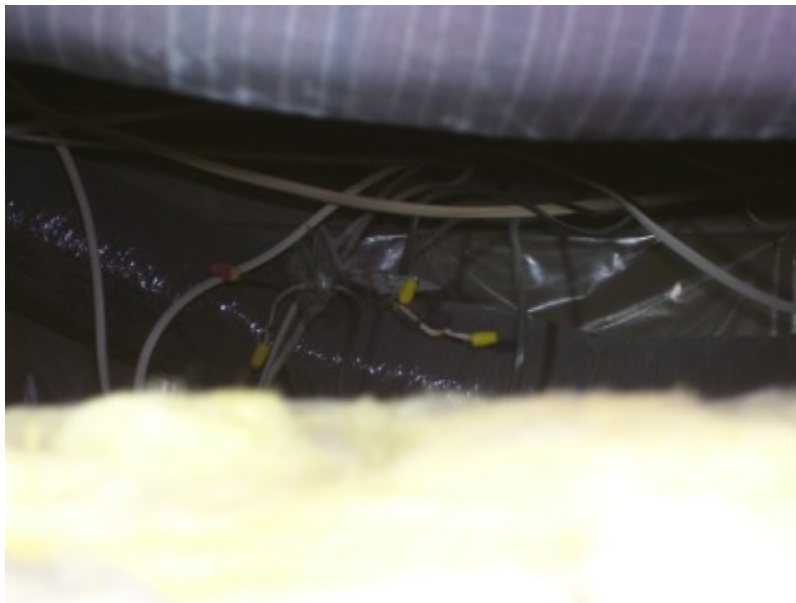
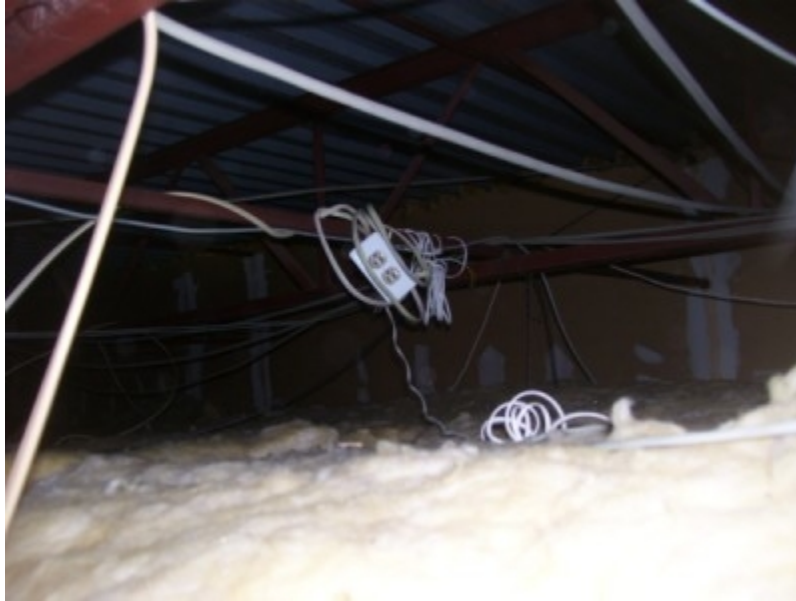
When checking areas above suspended ceilings, I found improperly terminated circuits. This includes junction boxes and outlets simply suspended above the ceilings and some exposed connections. Have a licensed electrician correct all the above.

6. Replace any stained ceiling tiles so the roof system can be monitored for additional leaks.
7. Have a licensed electrician make the electrical repairs and corrections indicated.

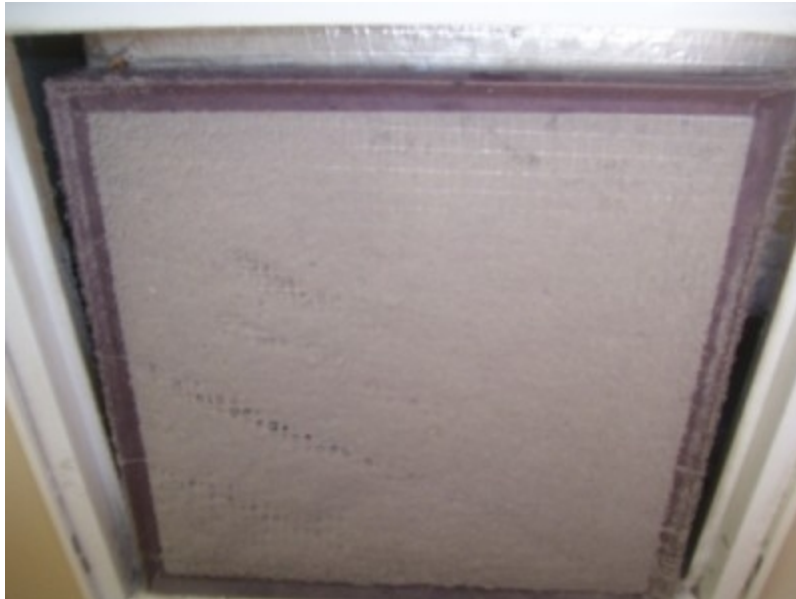
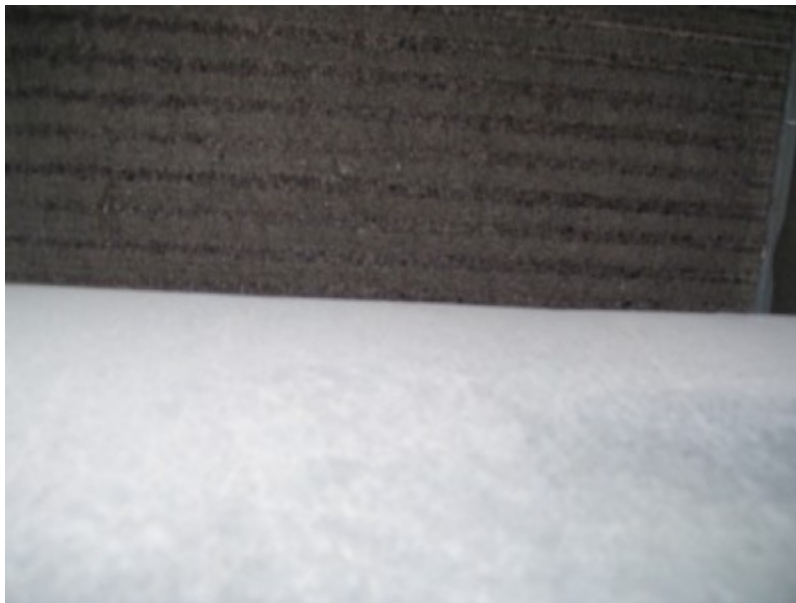
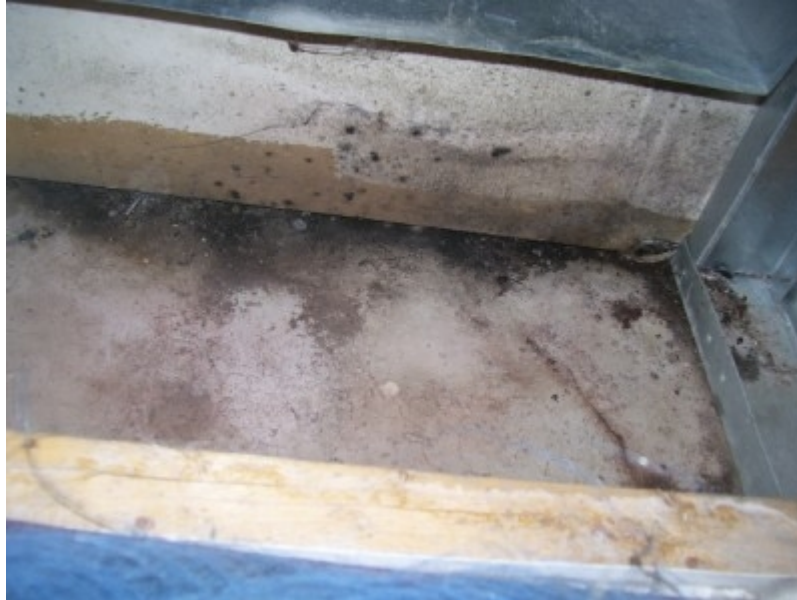
At the left unit of the dentist office, the filter is clogged. It is also the wrong size, and air has been bypassing the filter resulting in a significant accumulation on the evaporator coil which needs cleaning at this time. Behind the filter, inside the return air plenum, I found some black organic growth that is likely mold.

8. Have an experienced HVAC contractor service and clean all the heat pump systems and make the corrections to the installations indicated.
9. Have the water supply and adequacy tested and consult with a testing regarding treatment to correct the "rotten egg" odor at the hot water faucets. Have the hot water system serviced, flushed, or replaced due to this odor.

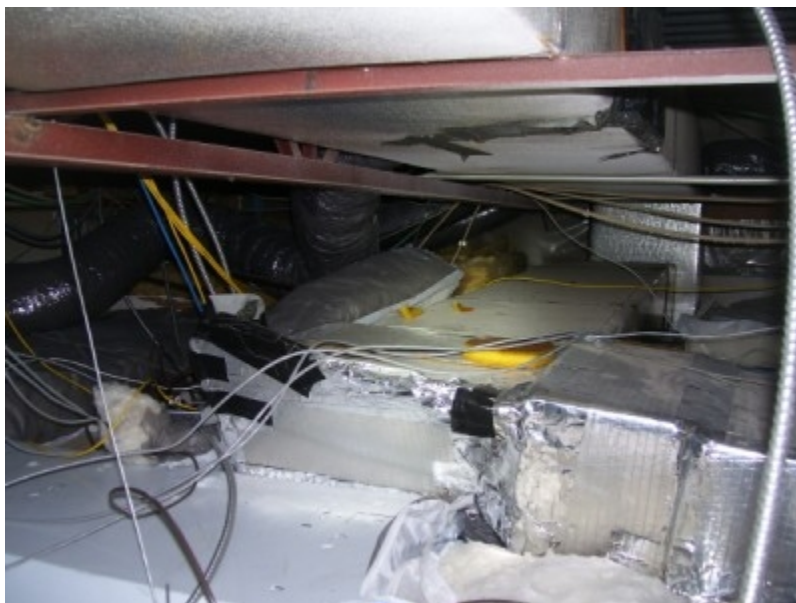
At the right unit in the dentist office, the return ducting above ceiling has crushed. Have the HVAC contractor repair this ducting.
